Free translation for GALVATOR[®] corrosion behavior

AMIRKABIR UNIVERSITY POLY TECHNIC TEHRAN

1- subject:

refer to the request of GHADIR ENGINEERING COMPANY (GCE Co.) for studying and doing the necessary tests on their product, which is CORROSION RESISTANT STEEL REBAR with the brand of GALVATOR[®], some samples of their product was delivered to the laboratory of surface coatings of polymer faculty – Amirkabir University to do the necessary tests and study about its corrosion protecting behavior and comparing it with uncovered carbon steel rebars.

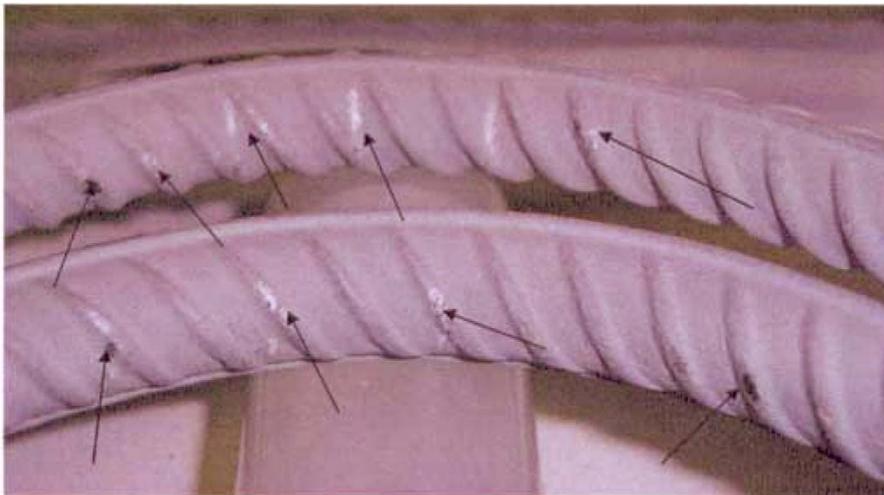
By inspecting carefully the bended GALVATOR[®] with magnifying lens, very small cracks were seen radiusly on the bending zone. But there was no detaching and peeling seen on the coating. Also at some places because of bending process the coating was scratched by the bending tools.

Figure (1)
Scratched places made by bending tools

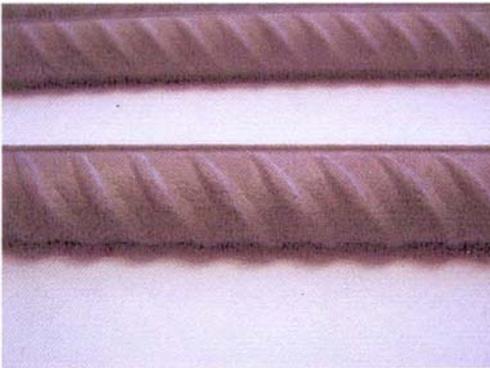
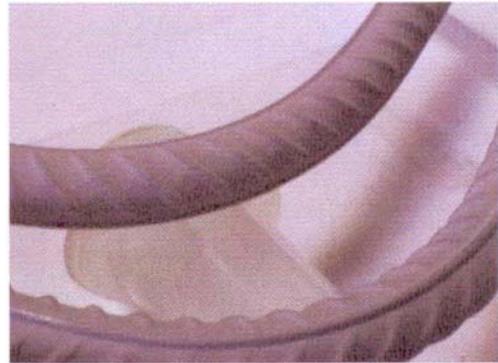
Specimens before test

Carbon Steel Rebars

GALVATOR®

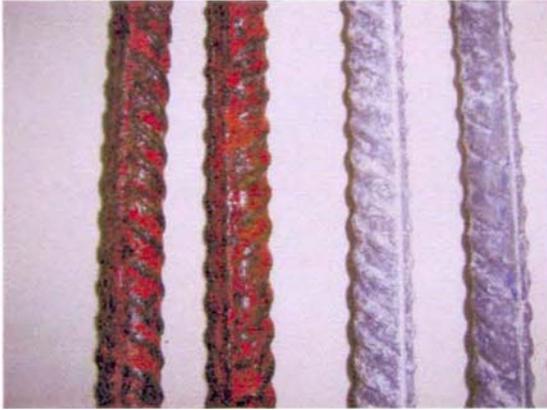
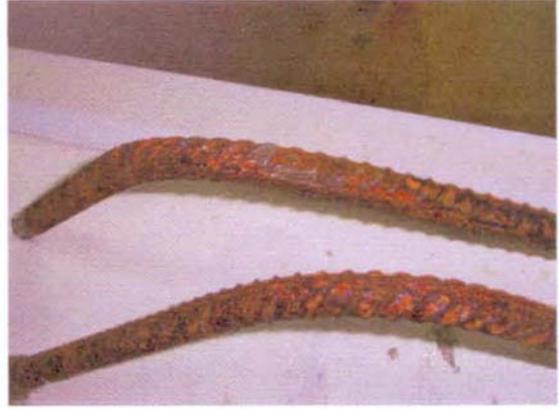
Figure 3
48 hours after salt spray

After 48 Hours from beginning of the test the carbon steel rebars rusted highly and for preventing the spreading of rust in the salt spray cabinet the carbon steel rebars were taken out.

Carbon steel Rebars after 48 hr. salt pray

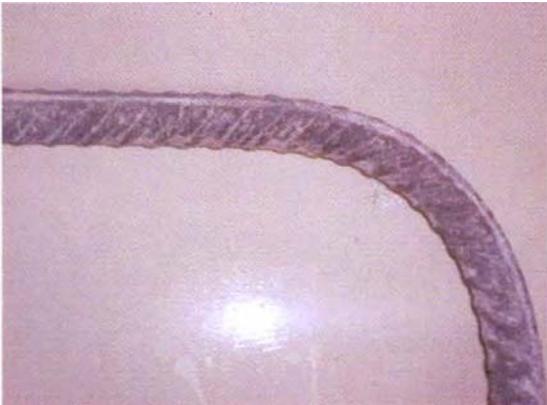
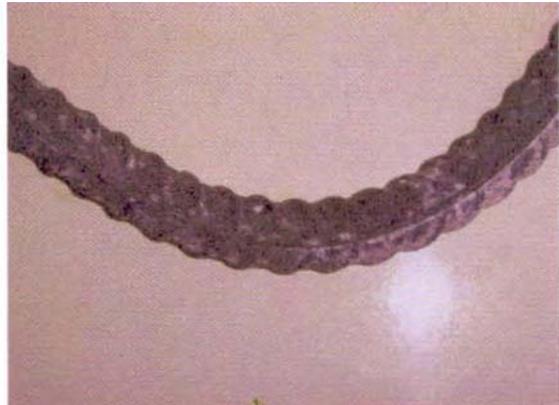
Time	GALVATOR®	Carbon Steel Rebar	Figure
At beginning of test	-----	-----	2
48 Hours	Forming oxide and hydro-oxide of zinc on the surface of GALVATOR®	Highly rusted *	3
130 Hours	Increasing oxide complexes on the surface	-----	-
300 Hours	No changes on the amount of zinc oxide and no traces of rust	-----	4
500 Hours	No traces of any rust on GALVATOR®	-----	5

GALVATOR[®] after 48 hr. salt spray

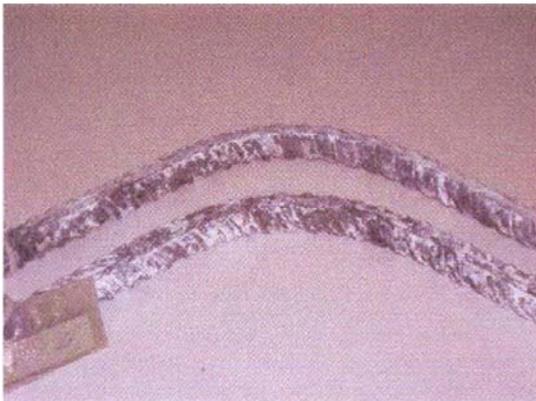
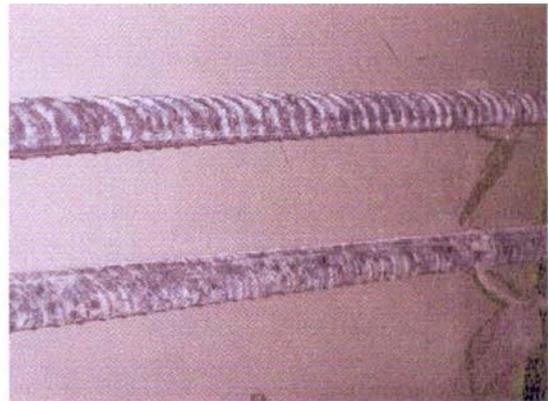
Figure 4
300 hr. after salt spray

GALVATOR© after 300 hours salt spray

Bended specimens

Straight specimens

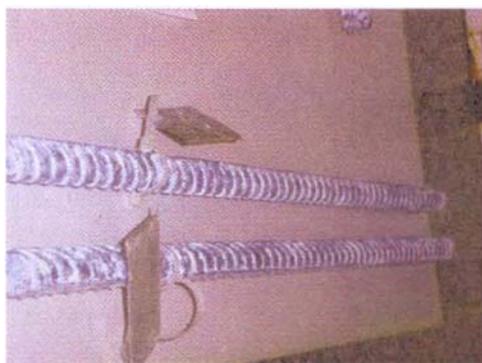
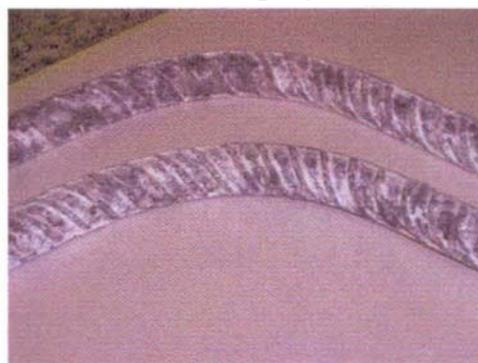
5-2- after 500 hours of salt spray test according to the ASTM D 610 and DIN 53210 standards there was no traces of rust seen on the surface of GALVATOR[®]. This illustrates the good resistance of GALVATOR[®] in corrosive environment.

5-3- in places that the coating was damaged because of bending application, no traces of rust were not seen. This effect is obtained for the cathodic behavior of GALVATOR[®].

GALVATOR® after 500 Hours salt spray

Straight specimens

Bended specimens

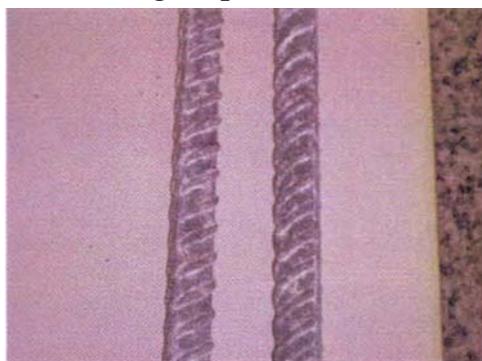
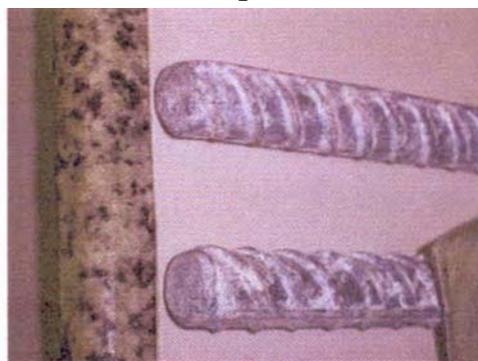
5-4- at the end of the test, no traces of peeling, detaching and blistering were not seen according to ASTM D 714 and DIN 53209 on the surface of the coating. This illustrates the good adhesion of coating with steel substrate.

GALVATOR® after 500 hr. salt spray
