HELL BRIDGE - NORWAY

In 2000, ZINGA was applied on the steel structures of the Hell Bridge in Norway.
The bridge was inspected in 2007 and no touch-ups were required.

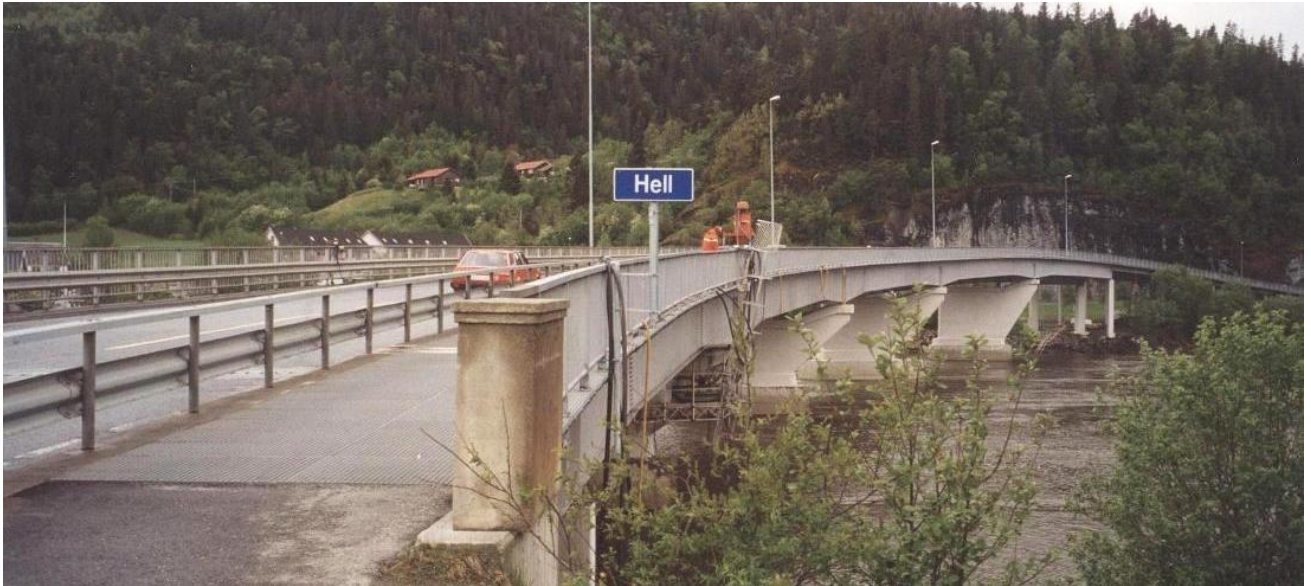
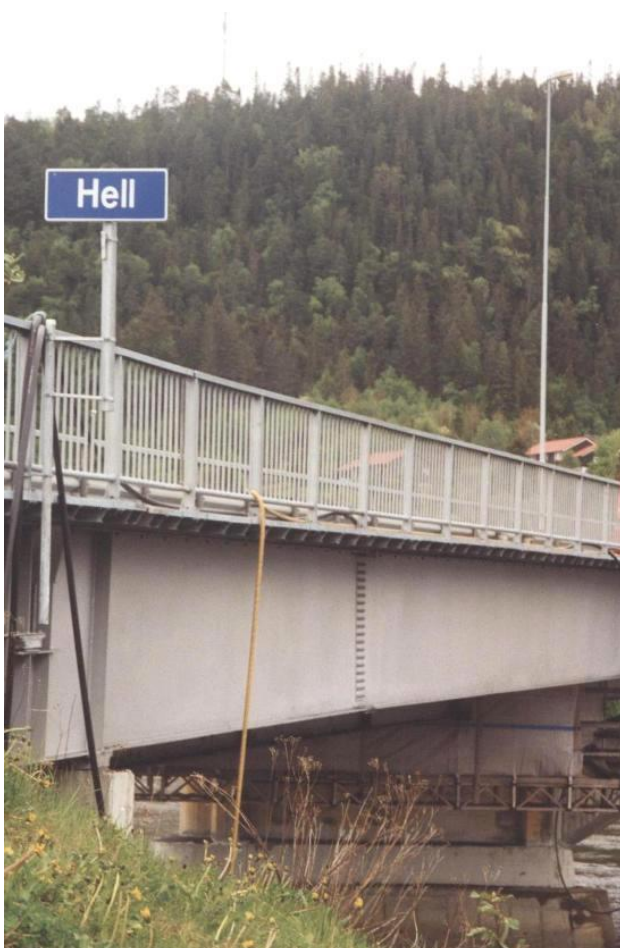
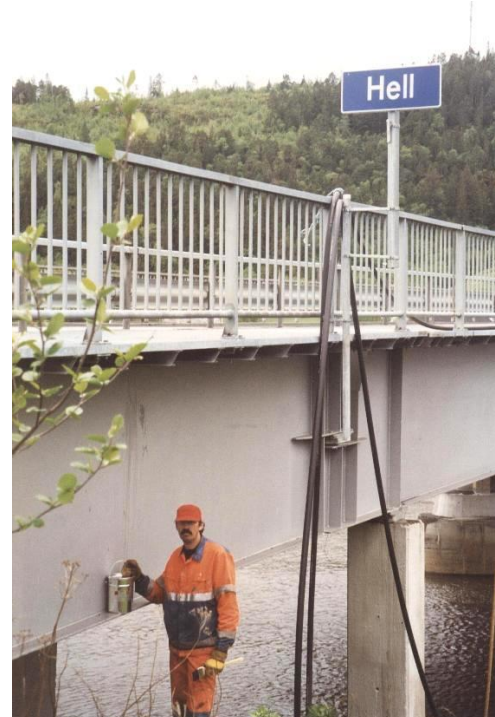
System:
Blasting to SA 2,5 and Rz 50-70µm
ZINGA 2 x 60 µm DFT

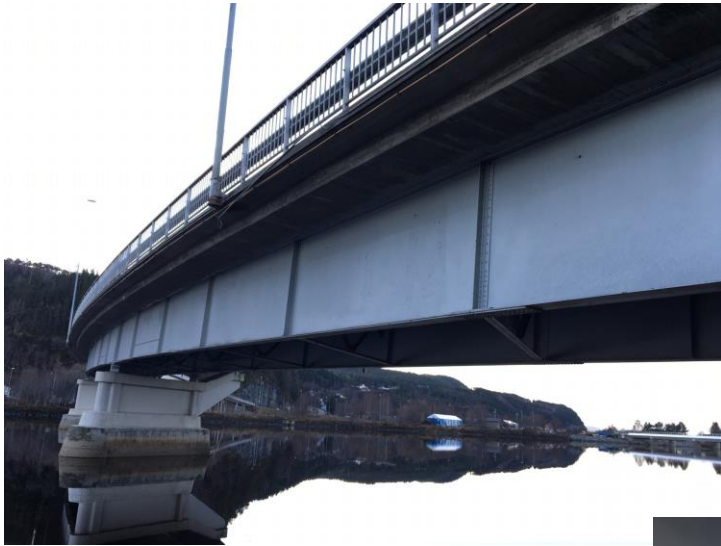
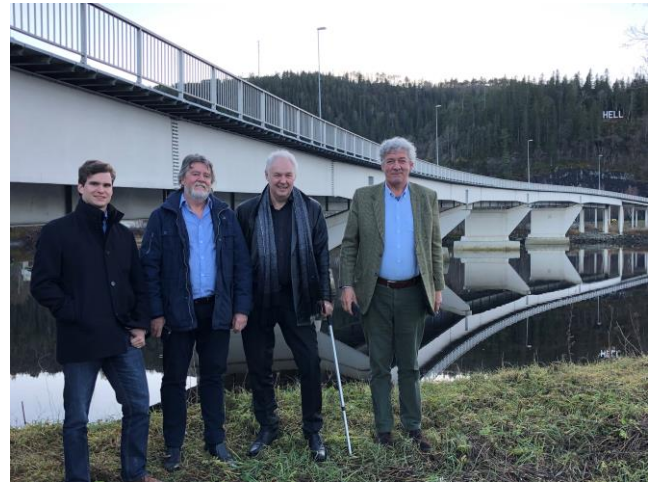
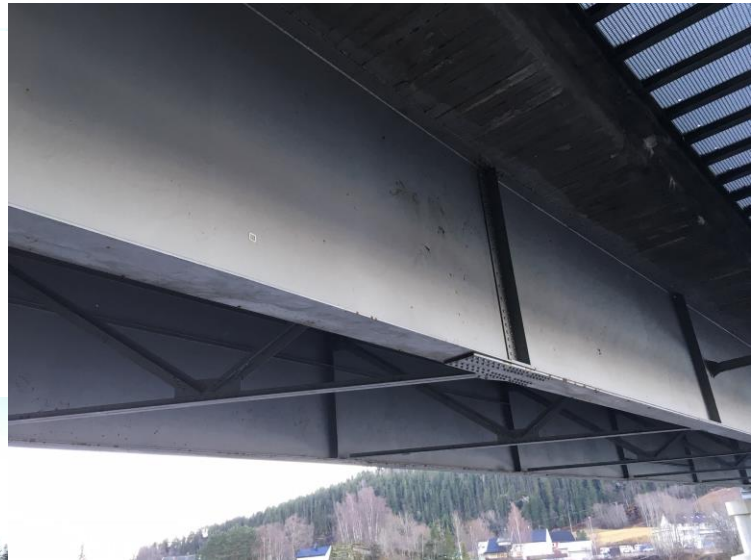
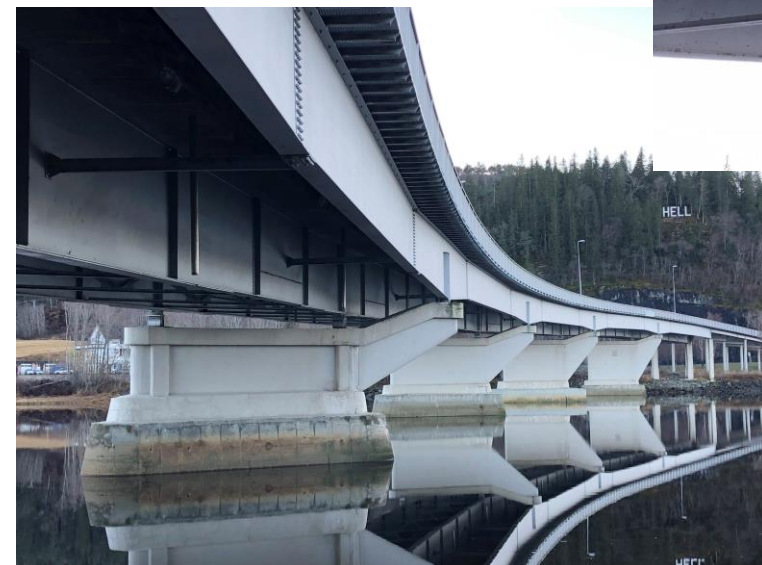
On 13 November 2018, **18 years after the original application**, a visual inspection was carried out by ZINGA Belgium and ZINGA Norway.

Not any corrosion nor any adhesion defects could be spotted.

Seaside view
