WATER RESERVOIR – BRAZIL

In 2013, a water reservoir tower located near beach houses in Sao Paulo, was treated with ZINGA.

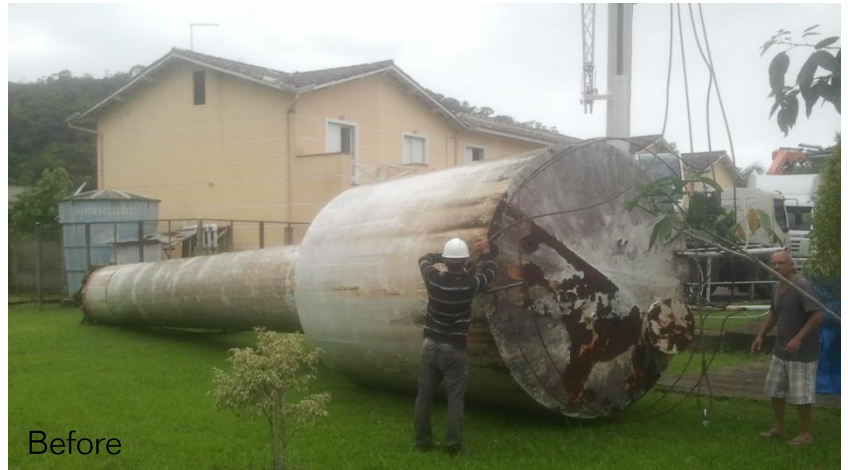
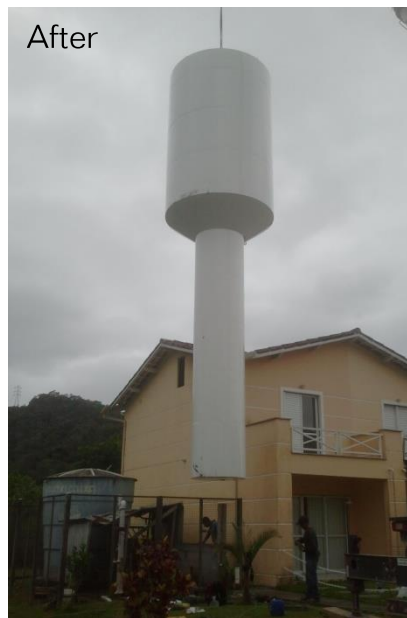
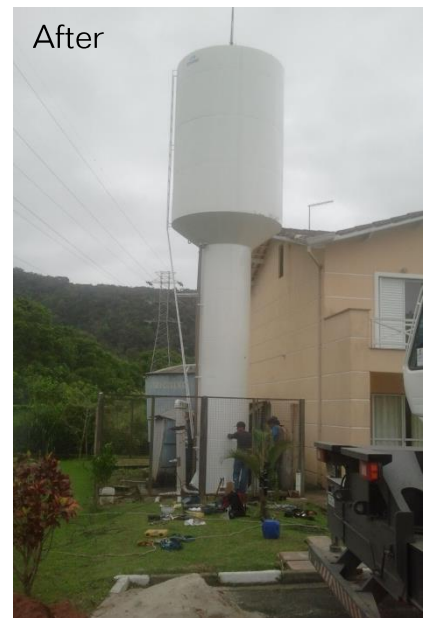
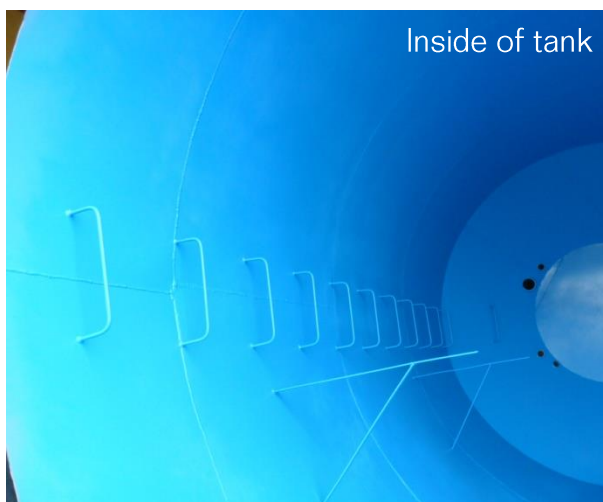
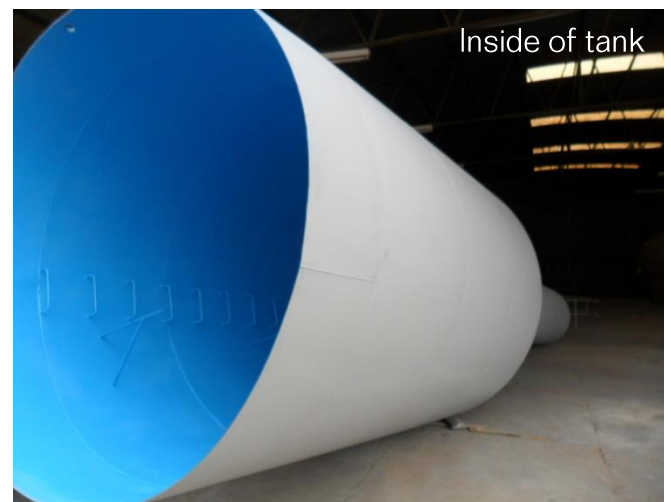
The water reservoirs were badly corroded. After dismantling of the towers, they were treated in a work shop. The surface was cleaned and blasted before a first application of ZINGA.

The external ZINGA layer was overcoated with a UV resistant PU, the inside was coated with an epoxy suitable for contact with water.

- ZINGA 60 µm DFT
- + Epoxy topcoat (inside)
- + PU topcoat (outside)
