KALVØYA BRIDGE NORWAY

In 1985 ZINGA was applied by brush on the steel structures of the Kalvøya Bridge in Norway. Paint gloves were used for the carrying cables.

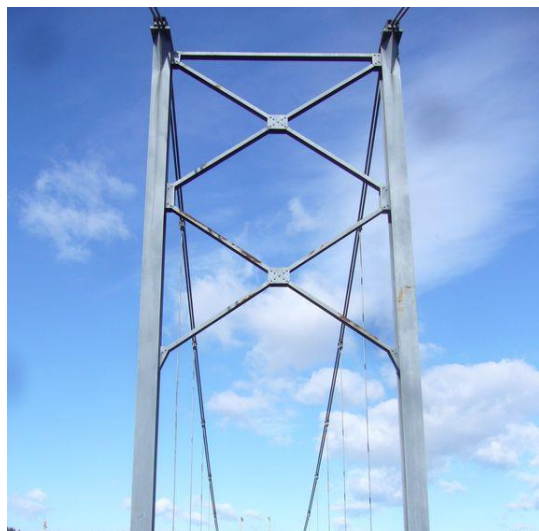
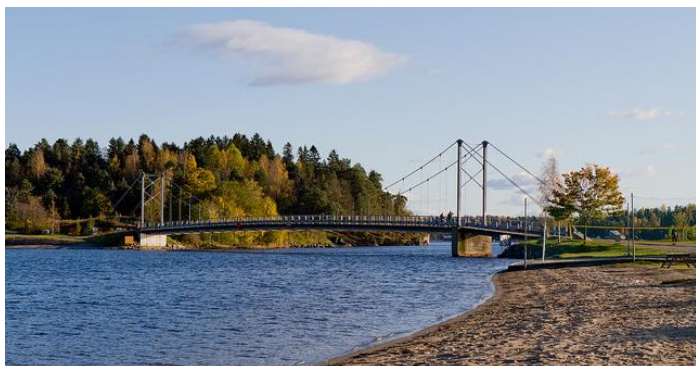
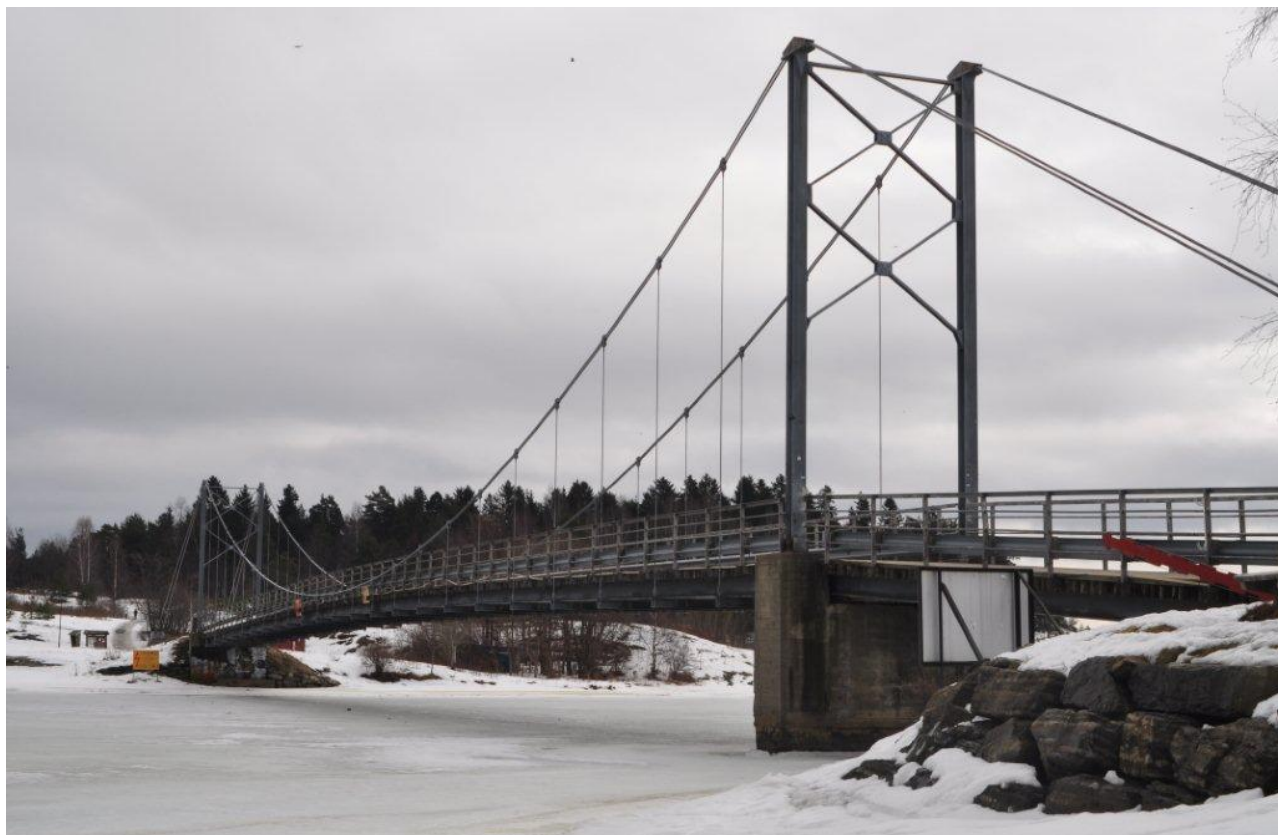
In November 2011, an inspection on the Kalvøya Bridge was done by Sven Ola Johnsen (FROSIO inspector).

“Good condition with no visible rust / pits on towers, beams, cables, hangers and railings, only locally “small rust spots”.
