**Subject: Adherence of concrete to rebars – differences observed between Zinga coated and other rebars**

You sent us different type of rebars (steel reinforcement in concrete mass):

- Type A: steel sandblasted, protected with Zinga prior to pouring of concrete
- Type B: steel not treated
- Type C: steel sandblasted

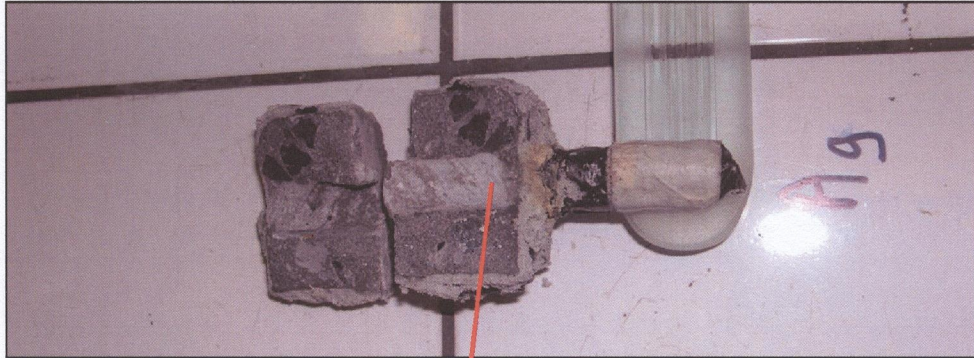
It is clearly more difficult to cleave the rebar bloc containing the steel rod protected by Zinga. The adherence of the concrete to the steel rod is better. The actual cleavage happens in the concrete. See photos on next pages

Thin layer of cement and Zinga on steel rod

After cleaving, we noticed the rupture happened in the concrete layer, close to the steel rod. It took more force and cleaving attempts than with the uncoated rebars.

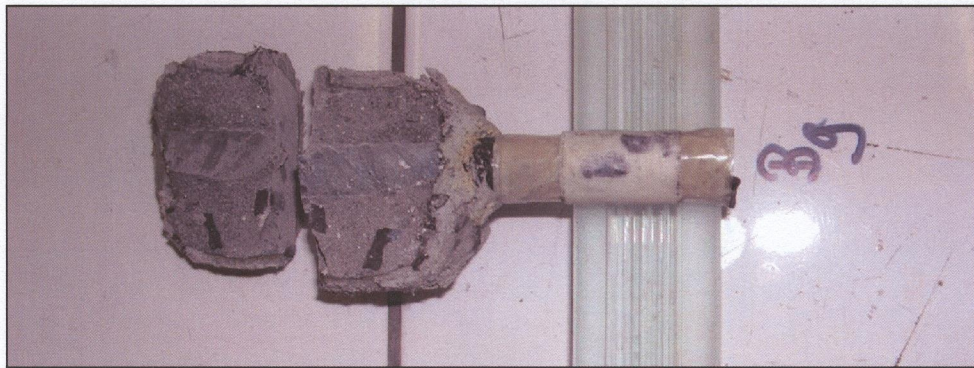
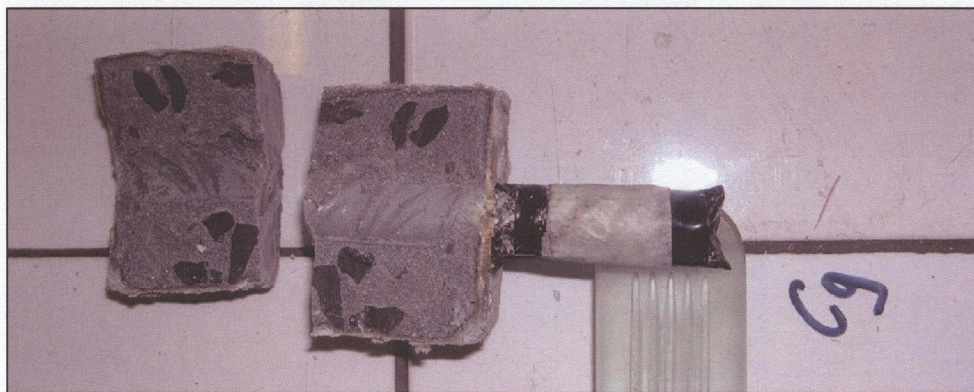
The other two rebars cleaved neatly between steel and concrete, which indicates a weaker adherence. As an adhesives specialist, I can confirm that cleavage between substrates usually indicates a weaker bonding than the internal strength of the substrates, which is generally considered a lesser adherence.
