WEGENFONDS BRIDGE – BELGIUM

The railings and the supporting steel structures of the bridge of the Wegenfonds in Afsnee (Ghent) were treated with ZINGA in 1985 by the applicator Peiniger. This bridge is built over one of the busiest motorways of Belgium, the E40 going from Brussels City to the Belgian coast (Ostend, Zeebrugge harbour), so it is constantly exposed to pollution.

Type of intervention	INSPECTION
Object	Balustrades Bridge of Afsnee – Gent, Belgium
Location	Gent, Belgium
Date inspection	16/11/2007

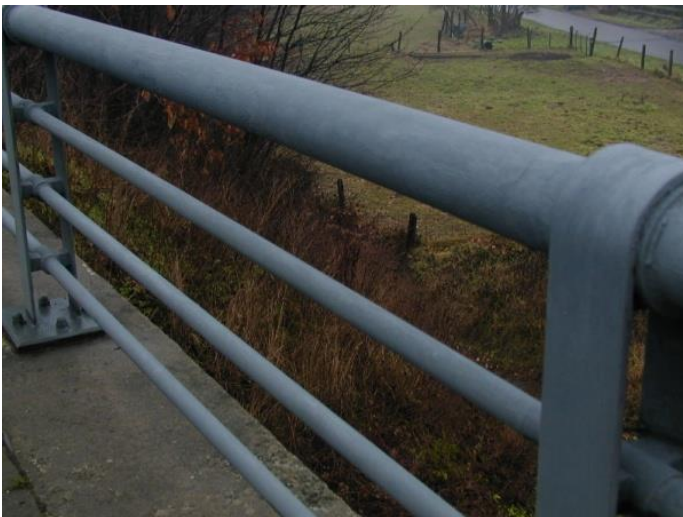
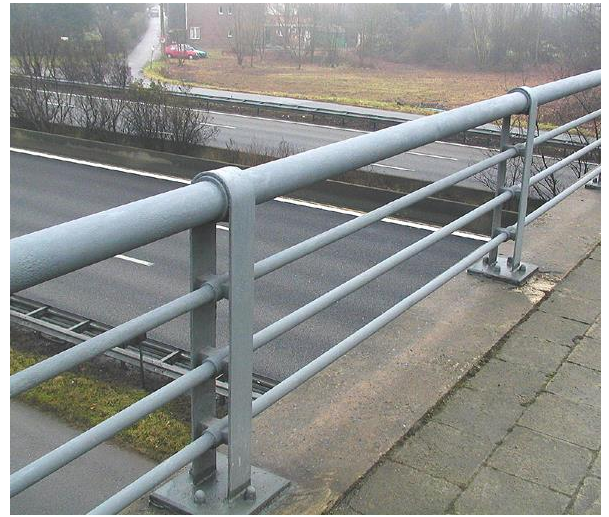
Pictures taken in January 2006 demonstrate that the ZINGA is still in excellent condition.

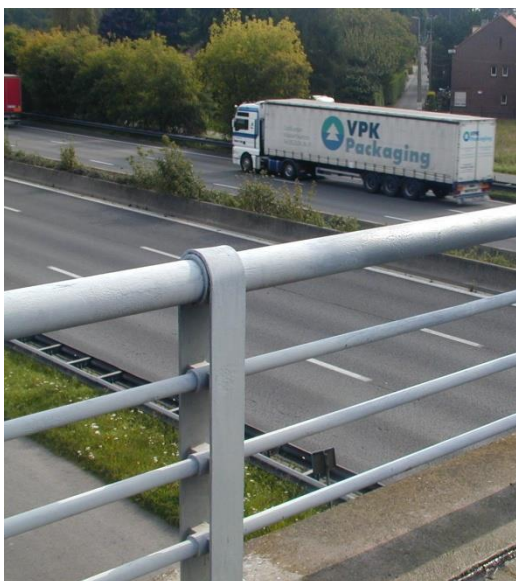
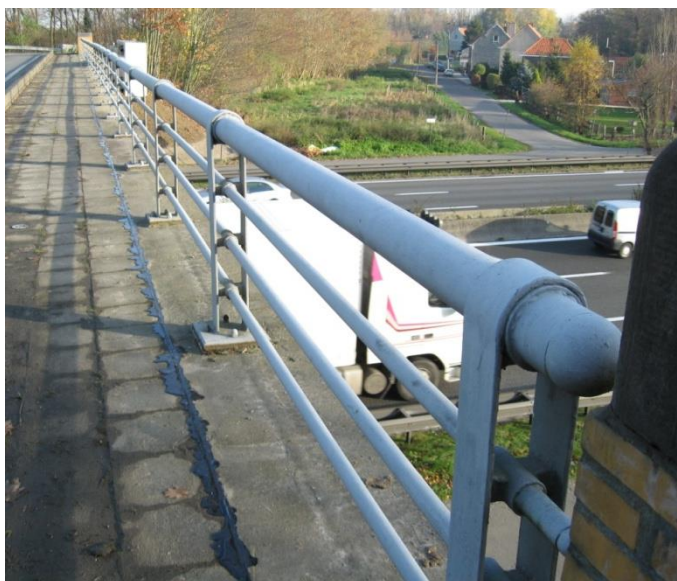
A visual examination was carried out to determine the integrity of the Zinga coating applied in 1985 to the balustrades of the Bridge of Afsnee situated in Gent, Belgium. The bridge is located over a motorway and during the winter months the coating is subjected to a highly saline environment from salting of the road.

The objective evidence demonstrates that where the coating has not been subjected to physical or mechanical damage, the coating was intact, soundly adhering and still fit for purpose 22 years after application.

In addition, where the breakdown of the coating that exposes the substrate has occurred, the lack of all but superficial corrosion demonstrates that the Zinga is providing the galvanic protection for which it was designed.
