KEIZER BRIDGE GHENT - BELGIUM

Pictures of the Keizer Bridge in Ghent, treated with ZINGA (80 µm) in **August/September 1996** by the applicator Pattyn under the authority of the customer Aswebo.

Type of intervention	INSPECTION
Object	Balustrades Keizersbrug – Gent, Belgium
Location	Gent, Belgium
Date inspection	16/11/2007

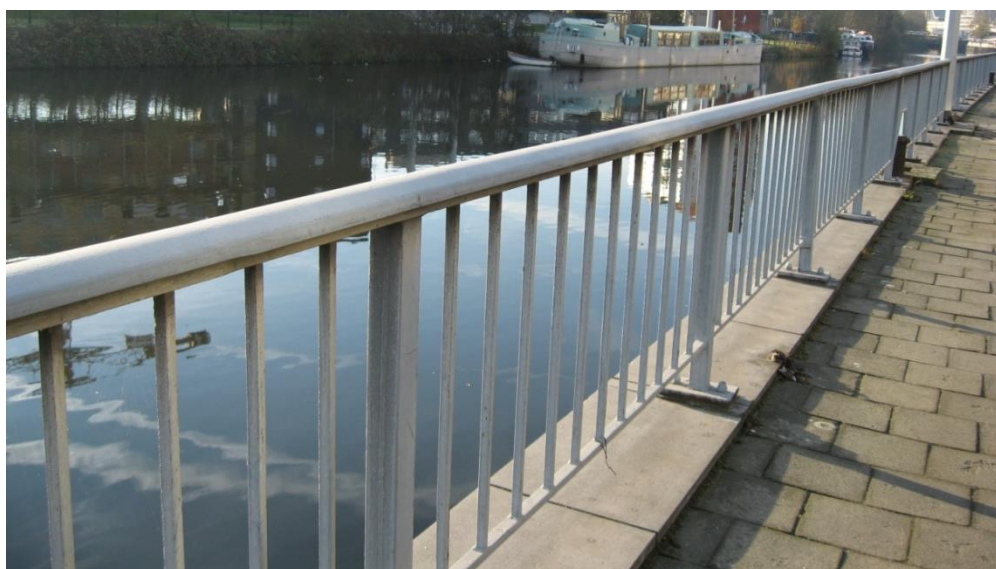
A visual examination was carried out to determine the integrity of the Zinga coating applied in 1996 to the balustrades of the Keizersbrug situated in Gent, Belgium. the bridge is located over a waterway and forms a major thoroughfare. As a consequence, during the winter months, the coating is subjected to a highly saline environment from salting of the road.

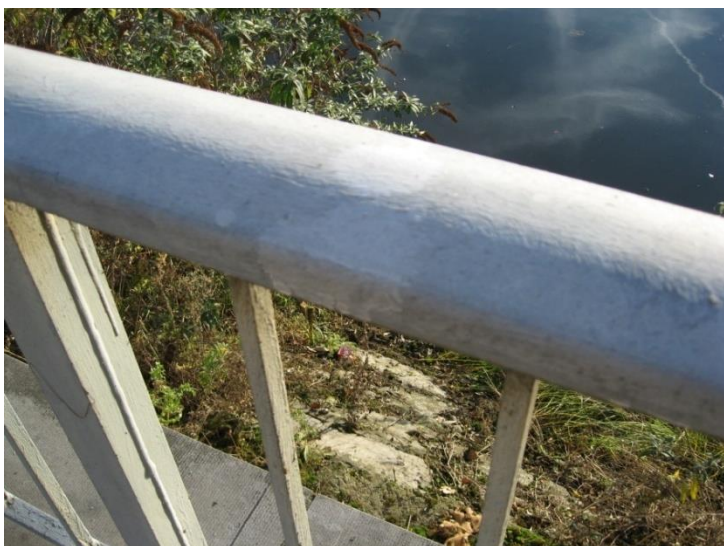
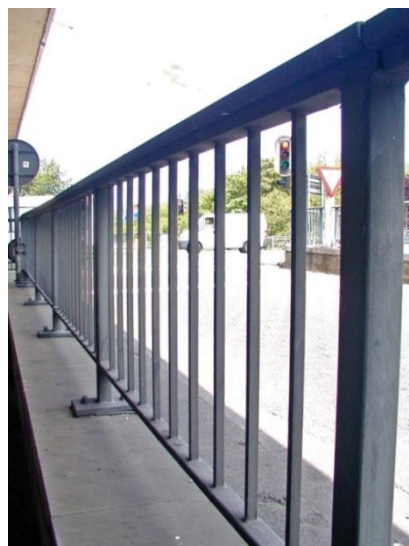
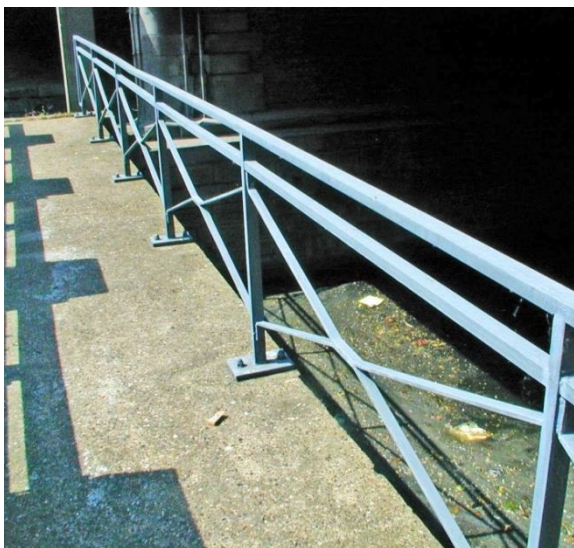
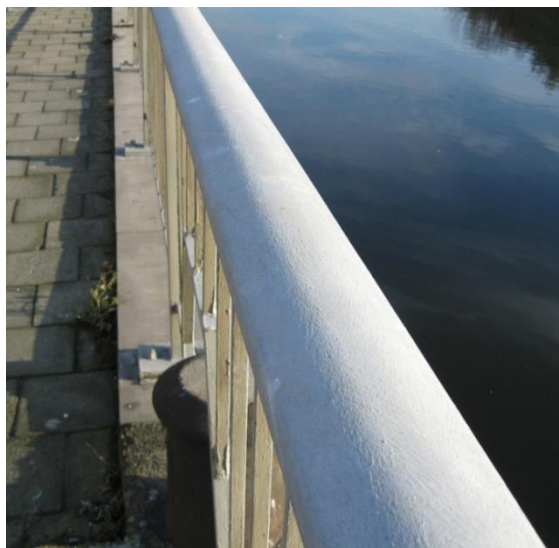
The objective evidence demonstrates that where the Zinga has been properly applied and not subjected to physical or mechanical damage, the coating was intact, soundly adhering and still fit for purpose 11 years after application.

In addition, where the breakdown of the coating that exposes the substrate has occurred, the lack of all but superficial corrosion demonstrates that the Zinga is providing the galvanic protection for which it was designed.
