Free translation for GALVATOR[®] corrosion behavior

AMIRKABIR UNIVERSITY POLY TECHNIC TEHRAN

1- subject:

refer to the request of GHADIR ENGINEERING COMPANY (GCE Co.) for studying and doing the necessary tests on their product, which is CORROSION RESISTANT STEEL REBAR with the brand of GALVATOR[®], some samples of their product was delivered to the laboratory of surface coatings of polymer faculty – Amirkabir University to do the necessary tests and study about its corrosion protecting behavior and comparing it with uncovered carbon steel rebars.

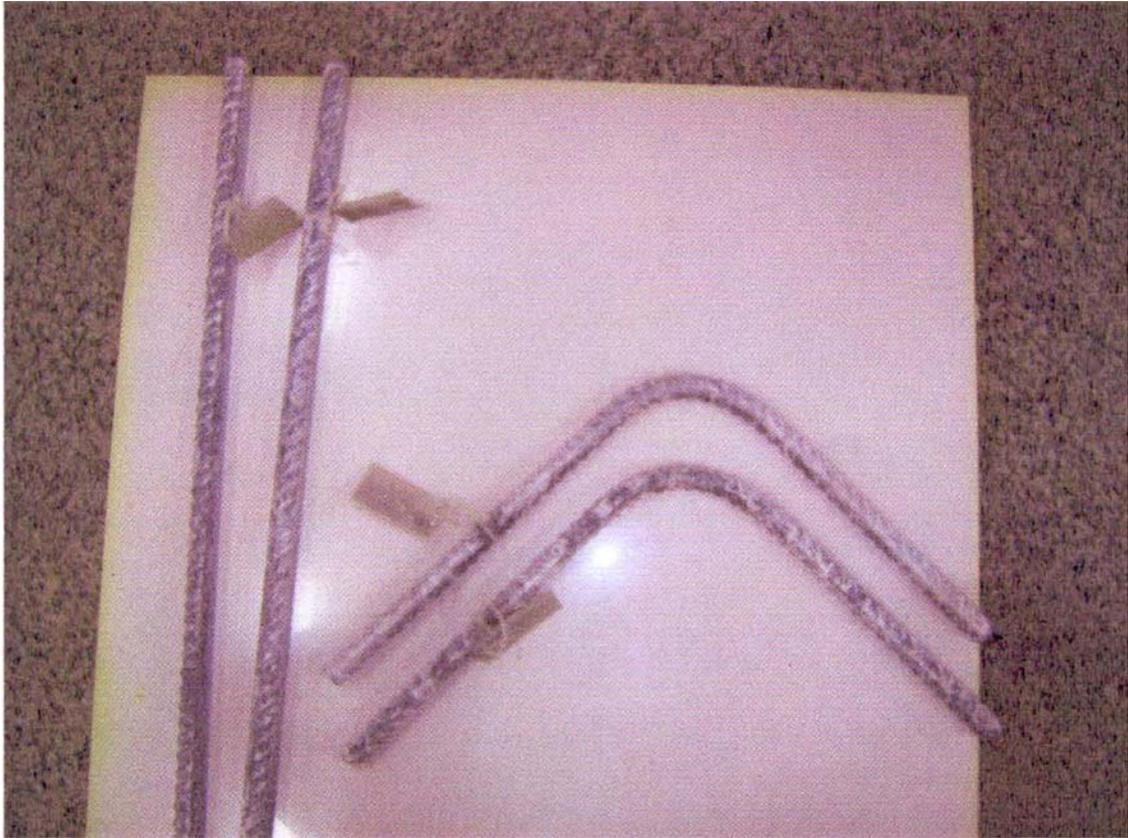
Time	GALVATOR®	Carbon Steel Rebar	Figure
At beginning of test	-----	-----	2
48 Hours	Forming oxide and hydro-oxide of zinc on the surface of GALVATOR®	Highly rusted *	3
130 Hours	Increasing oxide complexes on the surface	-----	-
300 Hours	No changes on the amount of zinc oxide and no traces of rust	-----	4
500 Hours	No traces of any rust on GALVATOR®	-----	5

GALVATOR© after 300 hours salt spray

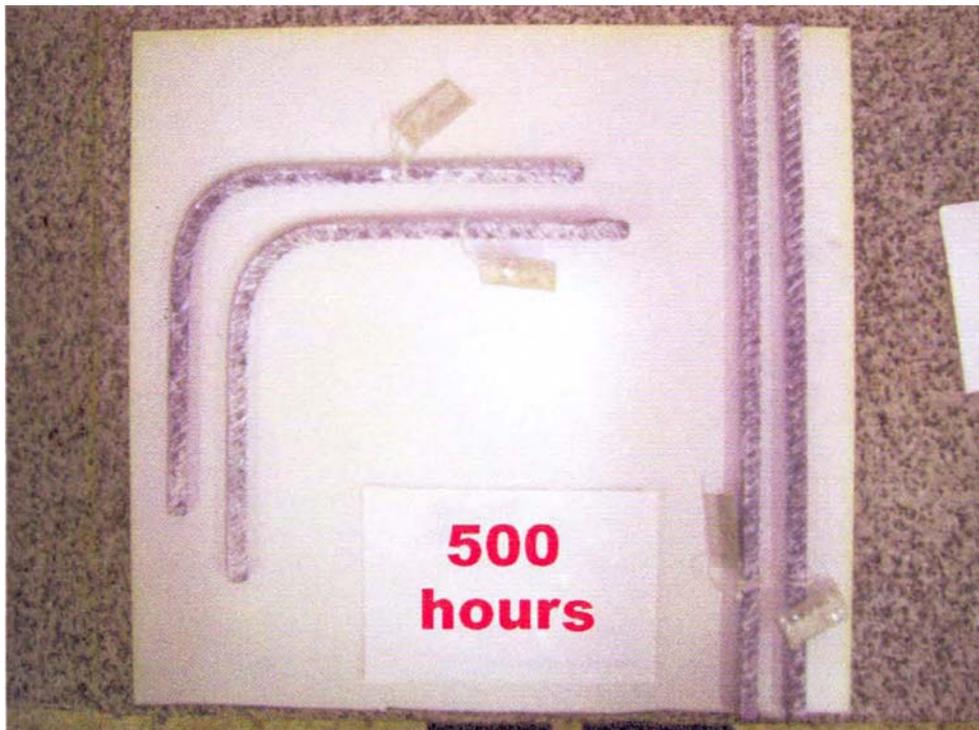
5-2- after 500 hours of salt spray test according to the ASTM D 610 and DIN 53210 standards there was no traces of rust seen on the surface of GALVATOR[®]. This illustrates the good resistance of GALVATOR[®] in corrosive environment.

GALVATOR® after 500 Hours salt spray
