CATTLE- AND PIGFARM – FINLAND

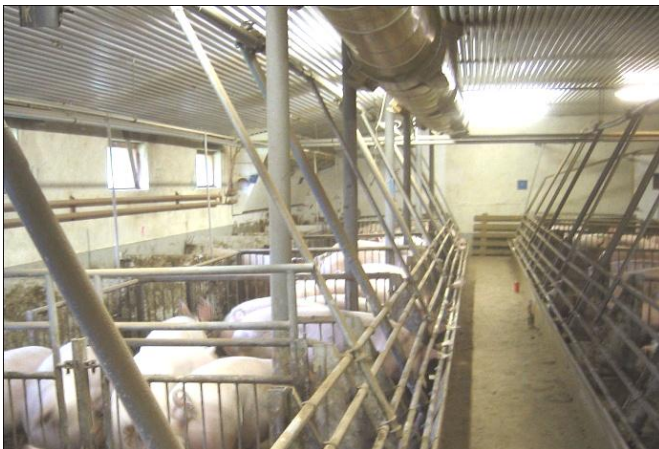
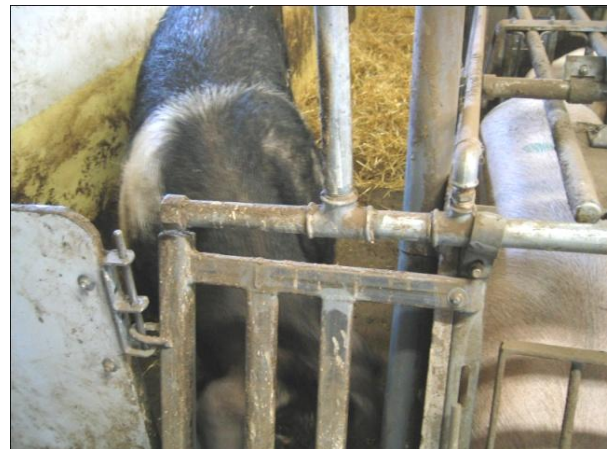
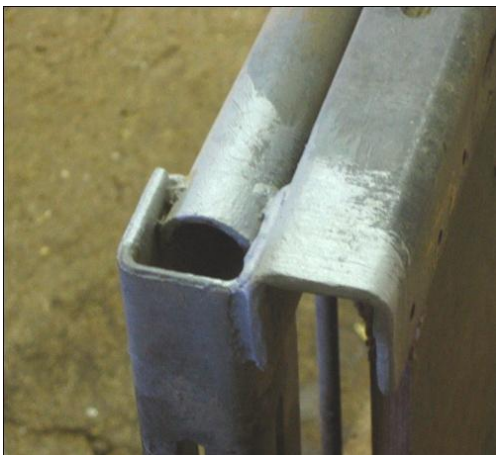
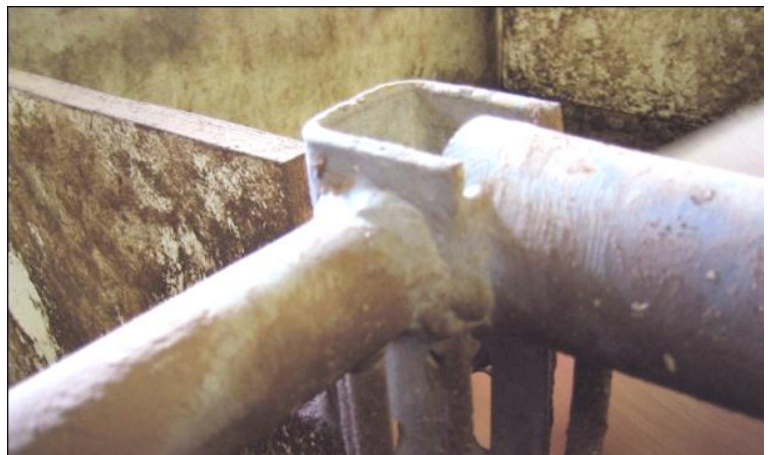
ZINGA has been used in pig farms already for nearly 15 years:
in re-coating existing galvanised surfaces and in recent years also using ZINGA as the only coating system.

Surfaces are sandblasted to at least SA 2,5 and ZINGA is applied:

- to normal areas 1 x 50 µm DFT
- fittings at floor level are treated with 3 to 4 layers of 50 µm which offers an even longer lasting surface.

ZINGA clearly offers better durability than a hot-dip galvanised surface. Also supervision and re-treatment of the anti-corrosion protection of the object is simple when using ZINGA.

System:

ZINGA 1 to 4 x 50 µm DFT
