BLANICE – RIVERBRIDGE – CZECH REPUBLIC

In August 1993, an 80 year old metal bridge over the Blanice River (40 km eastwards from Prague) was sand-blasted and only one layer of ZINGA was applied. There was not enough money at that time to apply a thicker layer.

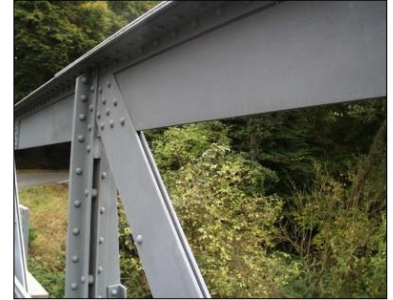
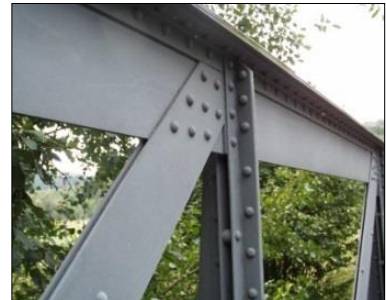
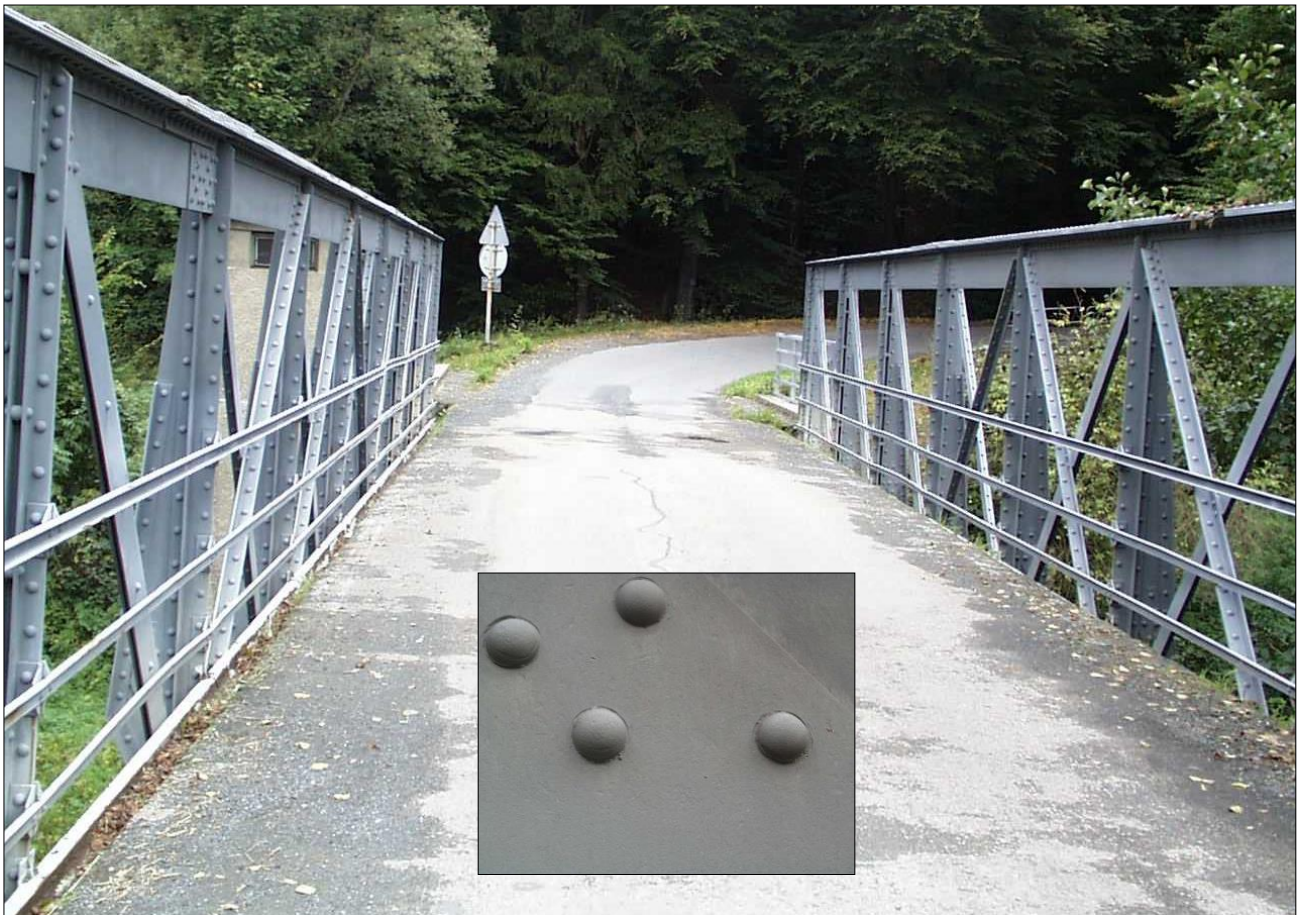
On 19/09/2000, the layer thickness was measured by Mr. Michal Stavar from the inspection company Grane, at an average of 40 μm to 55 μm DFT. There was no significant decrease in layer thickness.

System:
ZINGA 1 x 50 μm EFS
