## BRAITHWAITE TANK – UNITED KINGDOM

In 2005, the inside of potable storage tanks were treated with ZINGA.

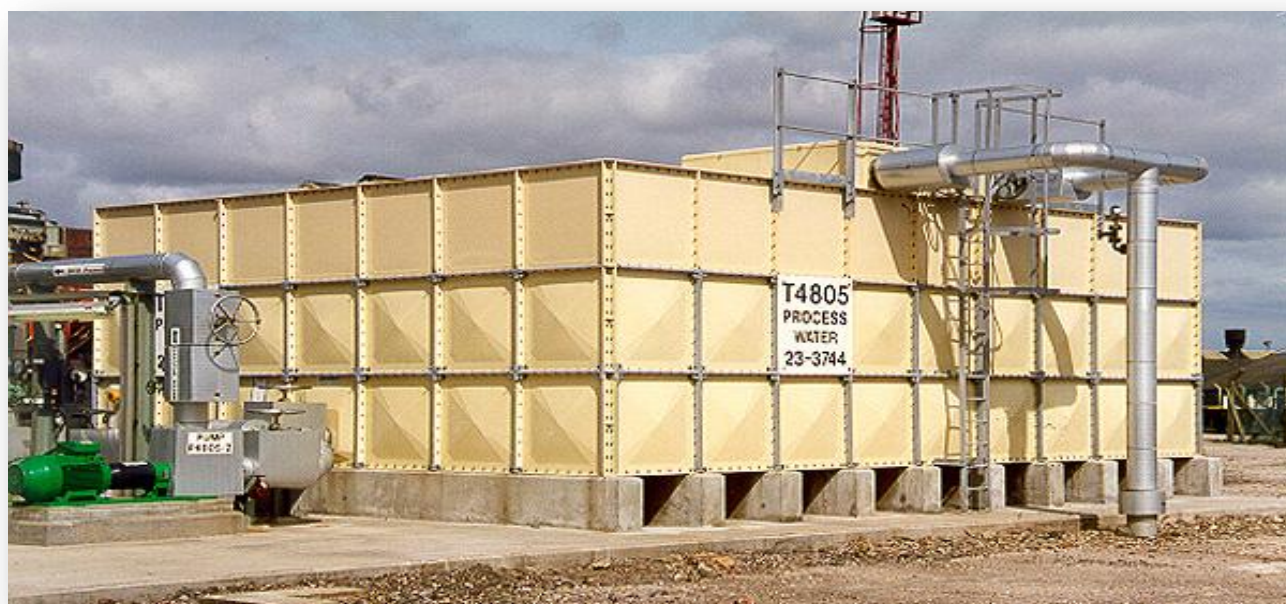
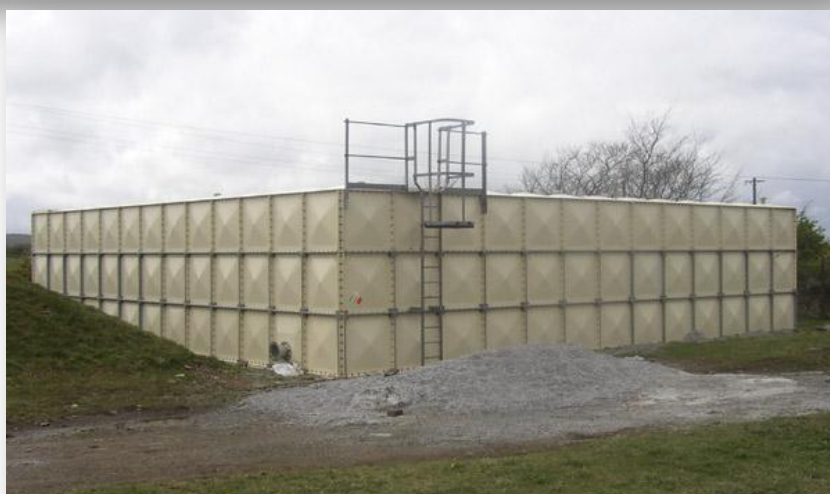
Below, you will find 2 photographs of Braithwaite tanks for potable water that are coated with ZINGA on the inside surface.

All together, nine of these tanks have been treated with ZINGA. Some of the tanks are bigger than houses.

On new tanks the surface was blasted to SA 2,5 and Rz 65  $\mu\text{m}$  and the ZINGA was applied by airless spray.

On old tanks the existing zinc was given a sweep blast at 50 psi using 45° nozzle angle and in this case, ZINGA was applied by short-fibre rollers and brushes for inside corners and flanges.

The layer thickness was 120  $\mu\text{m}$  DFT.

In all tanks the zingonised walls were sprayed with fresh water to avoid any risk on zinc taste or zinc small of the potable water.
